Protecting a critical manufacturing asset. How a flame-free roof replacement secured Smurfit Westrock's balehouse for the long term.

Case Study: Smurfit Westrock

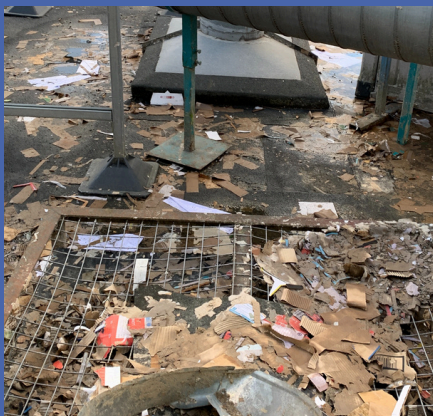
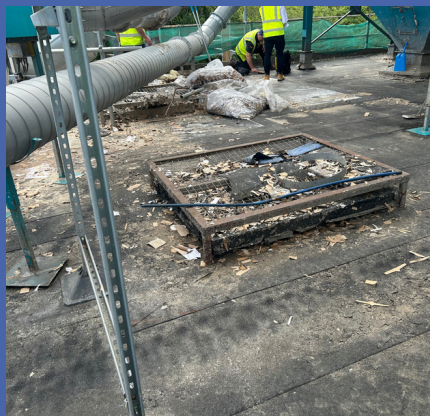
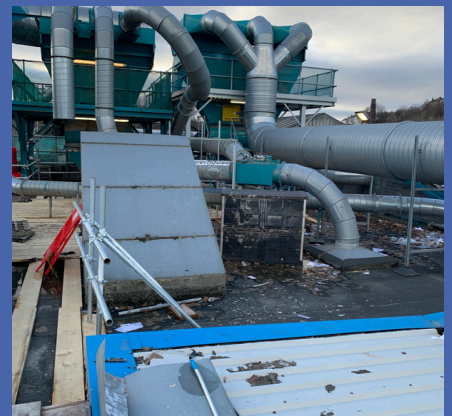
The balehouse could not be taken out of service, as it is a live manufacturing area handling highly combustible cardboard materials, with continuous operations running beneath the roof. This brought fire-risk, asbestos, structural and access constraints into a single scheme. Strip-out works uncovered rotten decking, defective joists and asbestos packers embedded within the structure, turning a controlled asbestos removal into a licensed operation with added compliance and programme pressure. Historic roof-on-roof construction had masked deterioration to the deck, joists and steelwork, while extensive penetrations, pipework and large hoppers served plant that could not be shut down or removed. Throughout the works the building below had to remain operational and watertight, requiring internal crash decking, exclusion zones and close coordination between all parties.

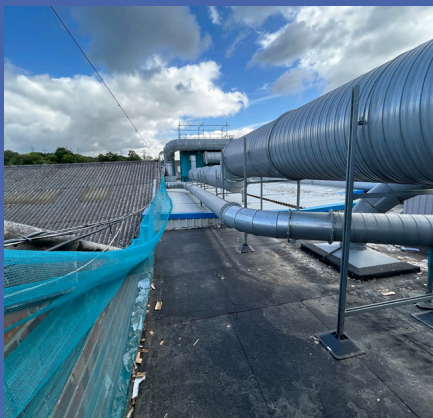
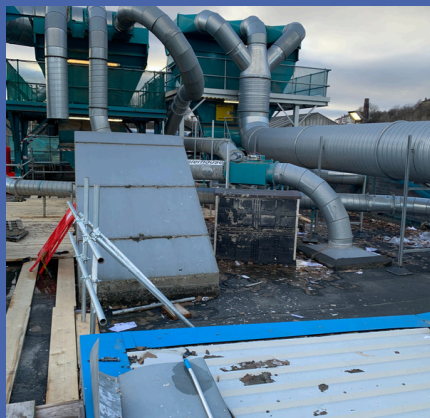
The existing balehouse roof comprised multiple historic layers, creating a roof-on-roof construction that had to be fully stripped back before works could begin. This exposed rotten decking, defective joists, corroded steelwork and asbestos packers. What started as a controlled asbestos removal quickly escalated into a licensed operation, introducing new compliance requirements, specialist trades and unavoidable pauses, all while the building below remained fully operational and watertight.
